Manhole Inspection Summary

Manhole # S25II2006MH

Location Address: **907 LAKE AVE**

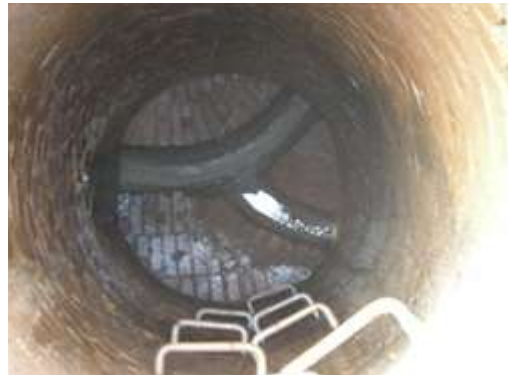
Top View

Bench debris.

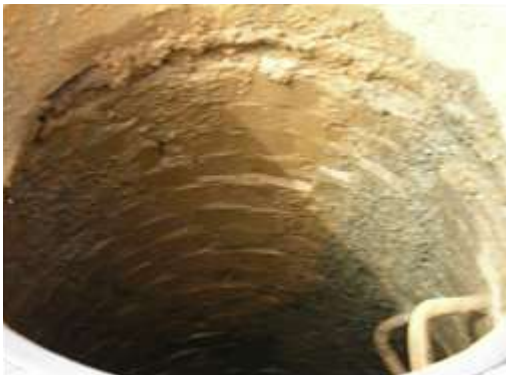
Defect

Frame Offset: **0** (in.) Condition: ☐ Sound ☐ Cracked ☒ **Leaks**

Condition: ☐ Sound ☐ Cracked ☐ Root Intrusion ☐ Loose Brick ☒ **Deteriorated**

Infiltration: ☐ None ☒ **Joint** ☐ Cracks ☒ **Mortar** ☐ Roots ☐ Wall

Infiltration: ☐ None ☐ Joint ☐ Cracks ☒ **Mortar** ☐ Roots ☒ **Wall**

Frame leaks. Adjustment deterioration and infiltration. Corbel infiltration.

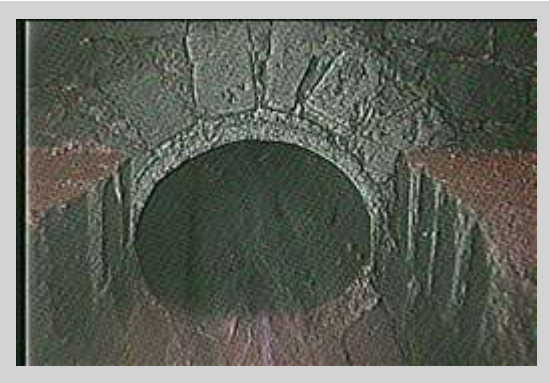
10 in. Circular Gravity Sewer Pipe Out @ 12 O'Clock

Barrel deterioration and infiltration.

Infiltration: **Evidence** Pipe Seal Cond: **Cracked**

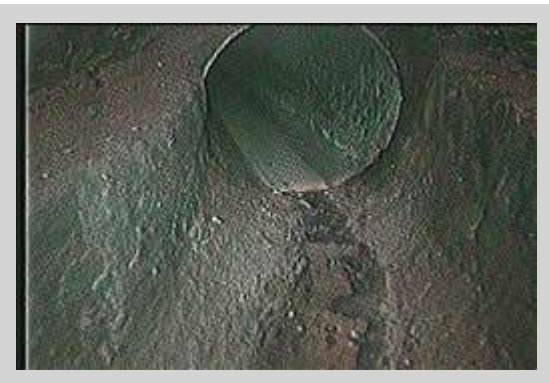
8 in. Circular Gravity Sewer Pipe In @ 3 O'Clock

Deposits: ☐ None ☐ Mud ☐ Sludge ☐ Debris ☒ Grease

Silt Depth: **0** (in.) Deposits Extent: **Light**

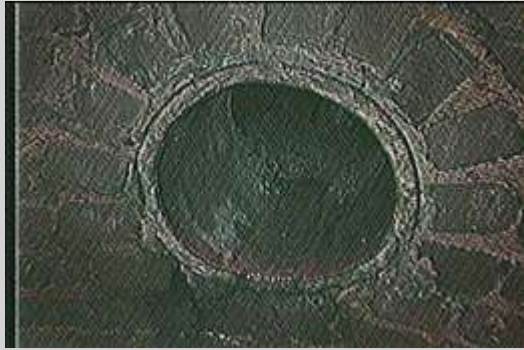
Pipe In @ 8 O'Clock

Infiltration: **Evidence** Pipe Seal Cond: **Unknown**

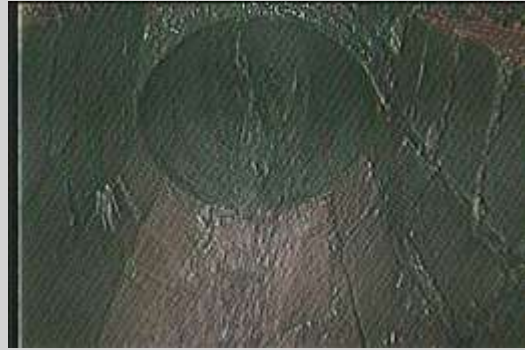
Drop In @ 8 O'Clock

Channel deterioration.
